Harding Lawson Associates

June 24, 1993

**Sewer - Storm Drain Interconnection
Parcel A/B Boundary near Building 101 & 110
Hunters Point Annex
San Francisco, California**

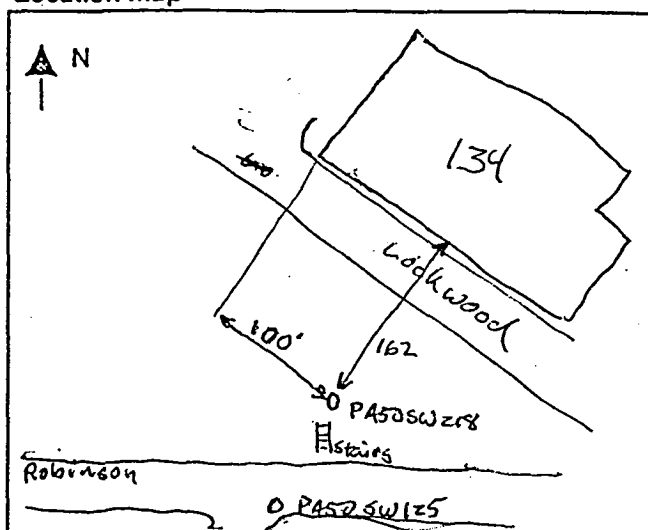
Location Map

Invert depth (TD)	: 5	Sediment depth:	unknown
Depth to water below rim	: 4.8	Sediment type:	Bricks, Pipe fragments, sand
Depth of water	: 0.2	Flow Rate (fast, slow, stagnant):	
OVA/Gastech readings:	4 ppm	Photo # / direction of view:	
Evidence of contamination:	strong sanitary sewer odor, water is grayish in color		
Vault conditions/other observations:			
Sample number(s)/matrix:
